NSWCCD-65-TR-2001/21 October 2001

Survivability, Structures And Materials Directorate
Technical Report

**Long-Term Health Monitoring of the Composite Road
Bridge on Delaware Route 896**

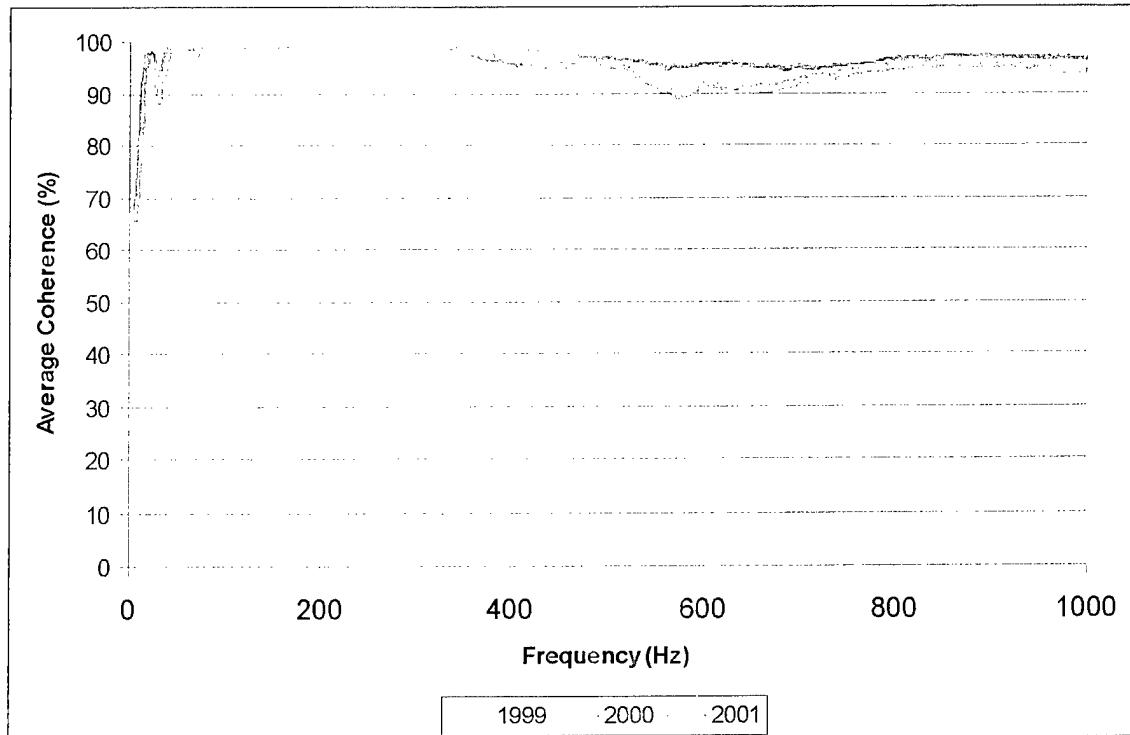
Figure 5. Average Coherence Function for the Three Years.

Figure 5 shows the coherence functions averaged for all measurements and all accelerometers, compared with the average coherence for the May 1999 and June 2000 trials. 100% coherence represents “perfect” data. Typically for large-scale vibration testing, anything over about 80% is deemed acceptable. As can be seen from the figure, overall the data quality is very high.

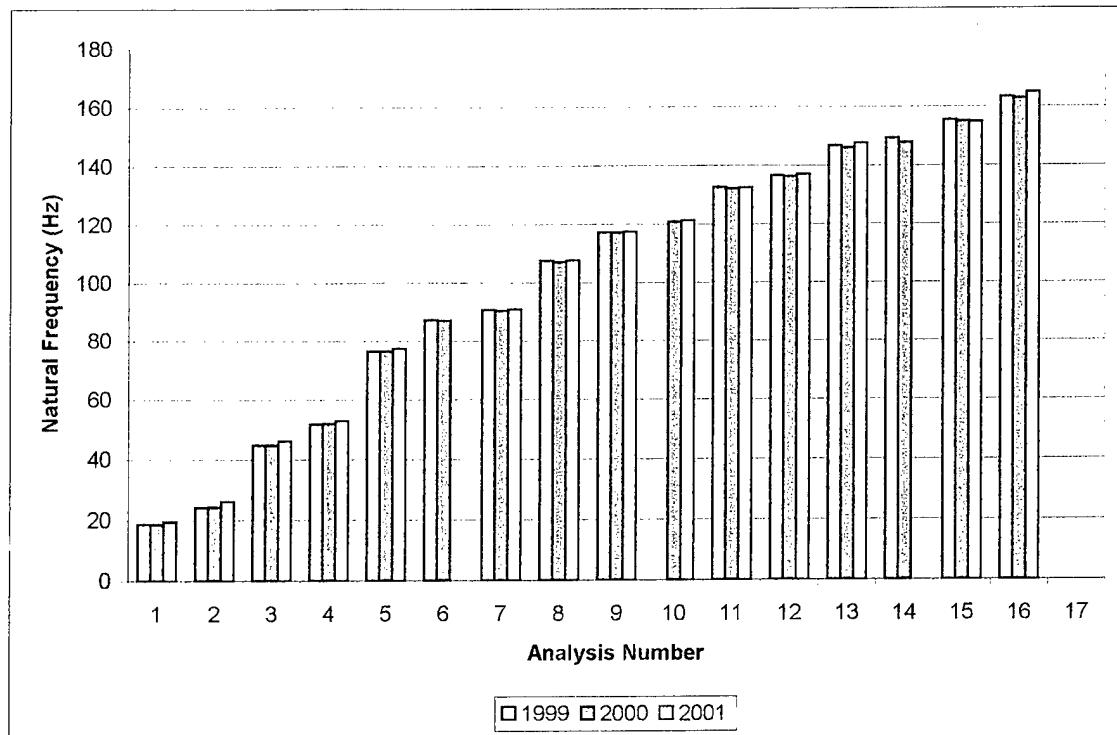
Figure 6. Natural Frequency vs. Analysis Number

The natural frequencies and modal viscous damping ratios are presented numerically in Table 1. The data in this table are shown graphically in Figure 6 and Figure 7. The viscous damping ratios in both the table and figures have been corrected for the error introduced into the data by the analyzer window constant, Reference 6. The figures also include the results from the May 1999 and June 2000 trials.

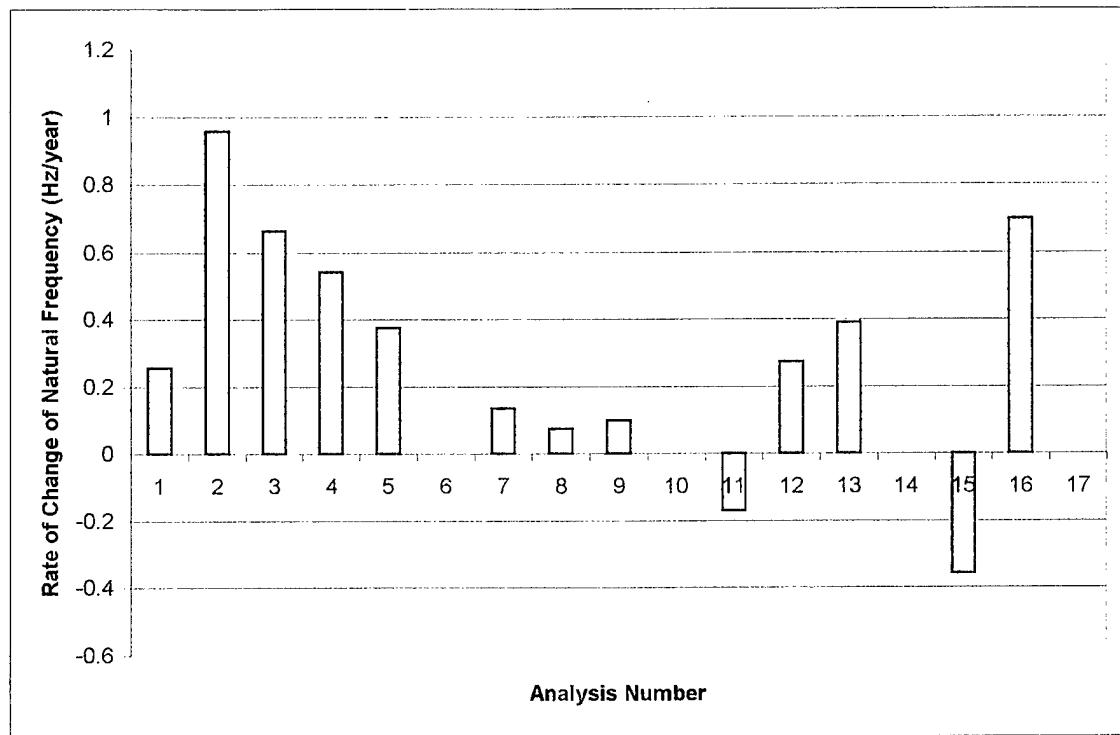
Figure 8. Rate of Change of Natural Frequency vs. Analysis Number

Of interest is the rate at which the natural frequencies are changing, since it would normally be expected that damage would cause a reduction in the natural frequencies. Figure 8 shows the rate of change of natural frequency for each analysis number. The rate is calculated as the linear regression of frequency versus time. The figure shows that all of the lower natural frequencies are increasing with time. This trend is contrary to expectations, and suggests that the level of structural degradation is very small, and having less effect on the natural frequencies than environmental effects. The increase in frequencies represents an increase in stiffness, since there is no observed loss in mass for this bridge.

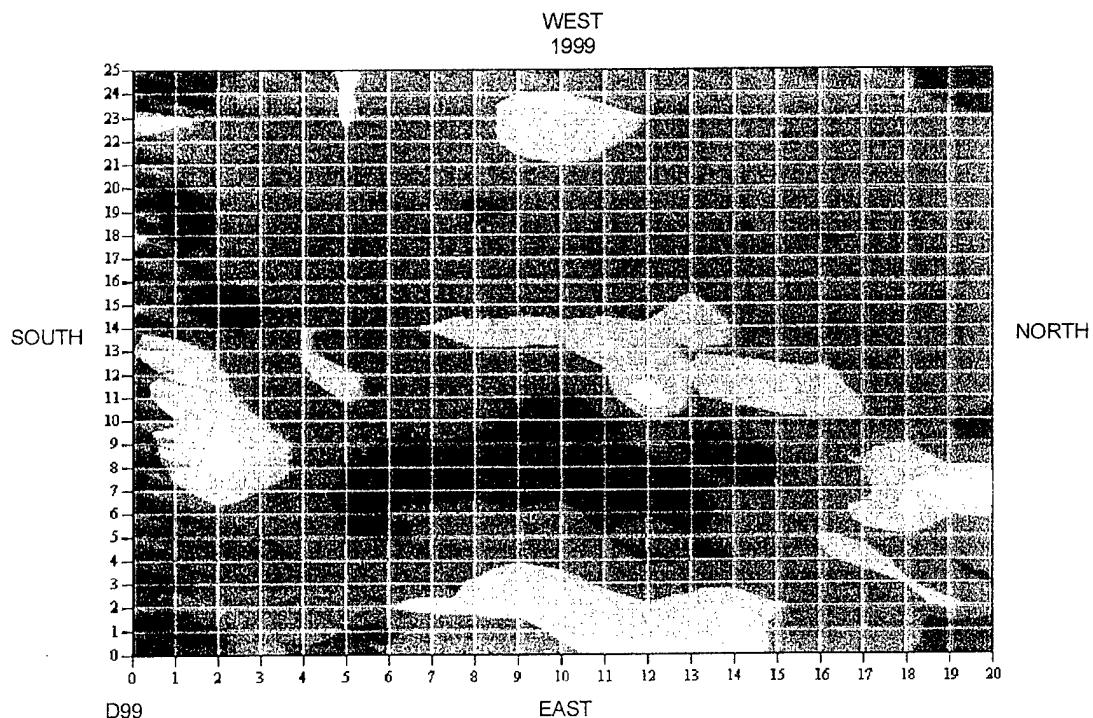
Figure 9. Raw SIDER for 1999

Figure 9 through Figure 11 show the raw SIDER results for 1999 to 2001 respectively.

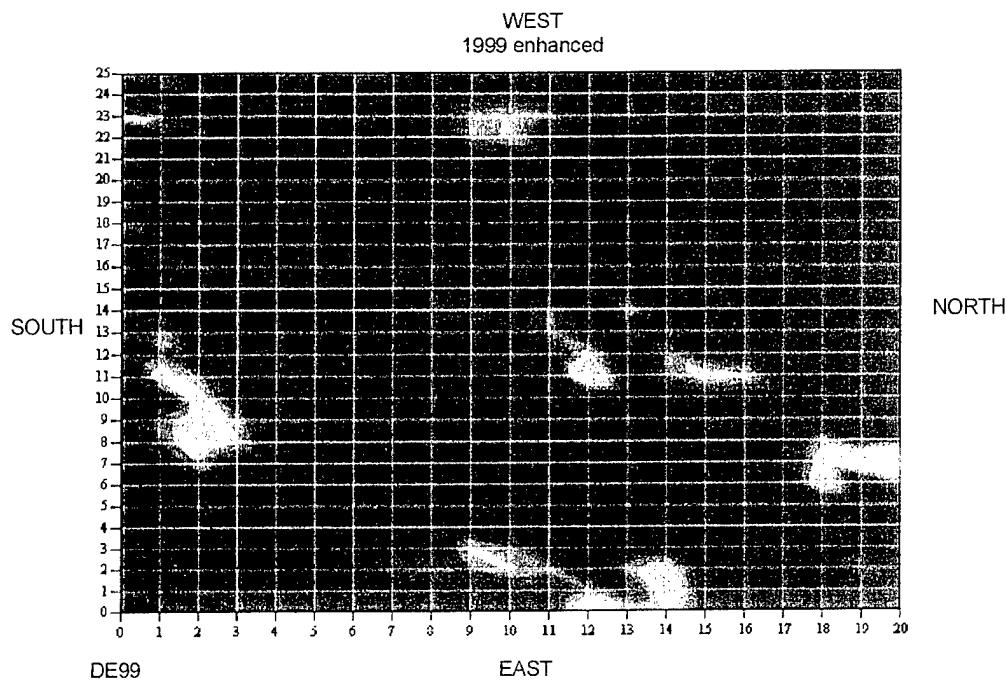
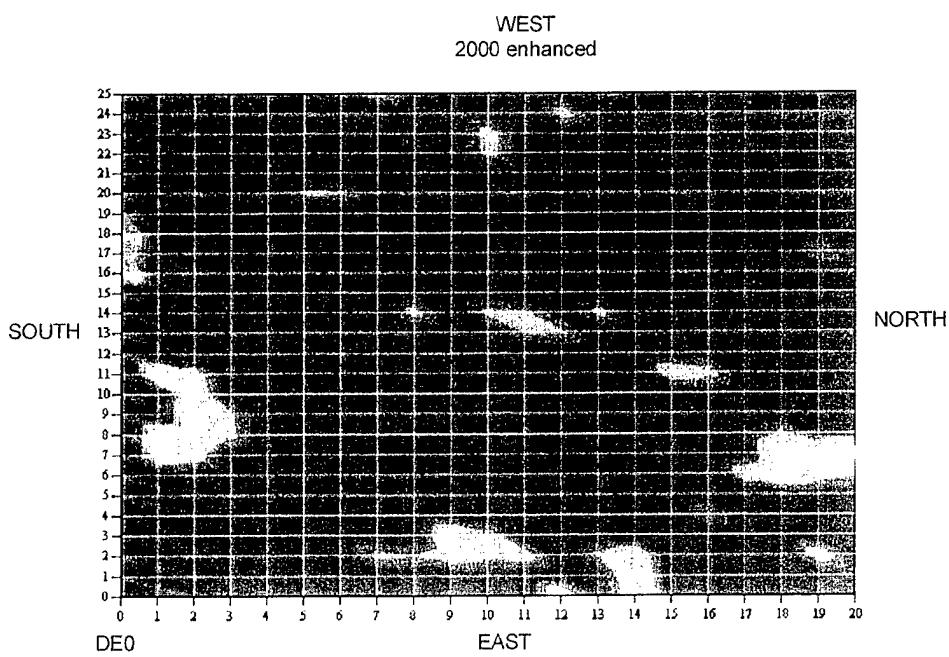
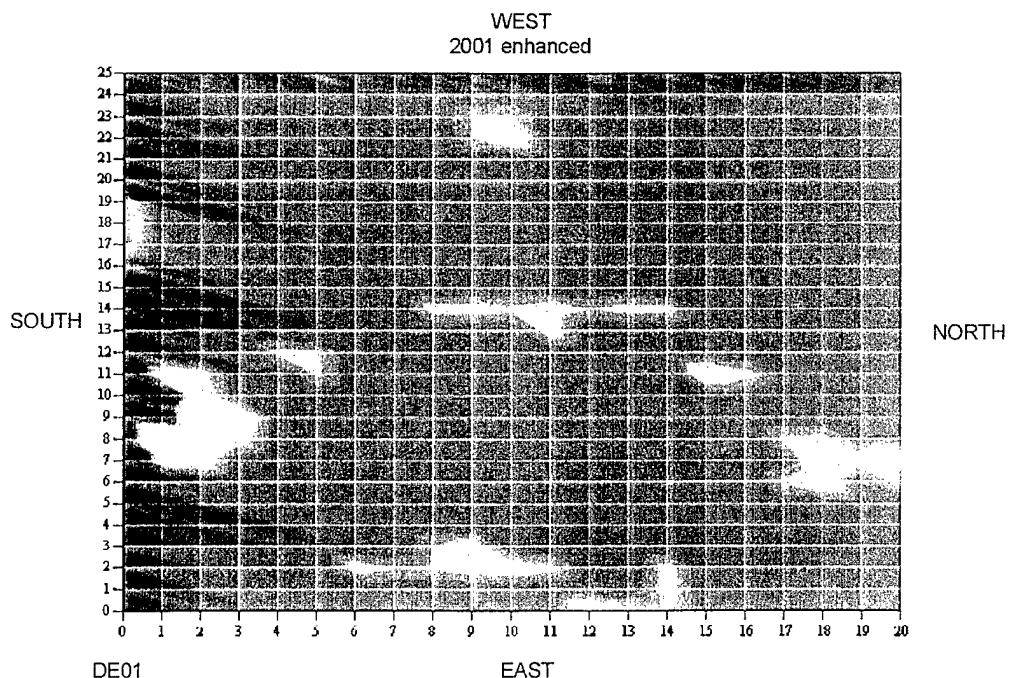
Figure 12 through Figure 14 show the statistically enhanced SIDER plots for 1999 to 2001 respectively.

The results of the SIDER testing show that there were some changes in the bridge from 1999 to 2001. These results are easier to observe on the statistically enhanced SIDER summary plots. The SIDER analysis has indicated there is some change in the structure near the south-east portion of the bridge.

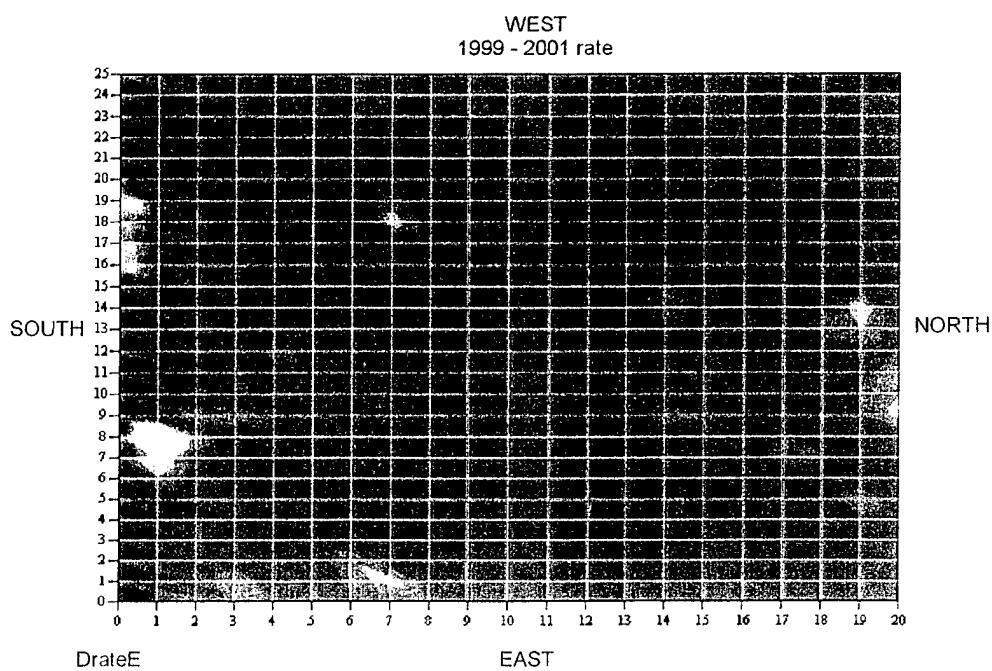
Figure 15 and Figure 16 show the raw and statistically enhanced SIDER rate plots respectively.
